## **TILES INSPECTION REPORT**

Product Description	600X1200MM PGVT

PO #		
Item #	60X120CM – PGVT	
Service Performed	FINAL INSPECTION REPORT	
Order Qty:		
Available Qty for inspection		
Batch Number		
Inspection Date		
Inspection Location	Morbi

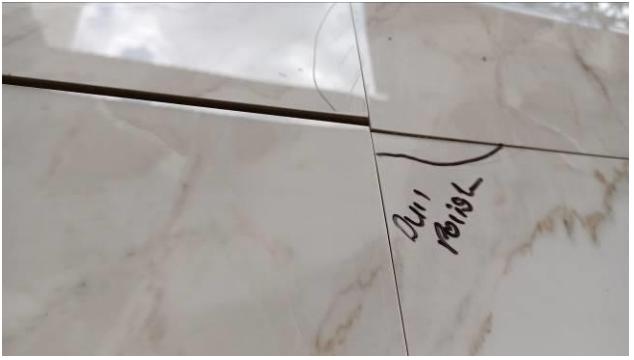
MINOR – PINHOLE

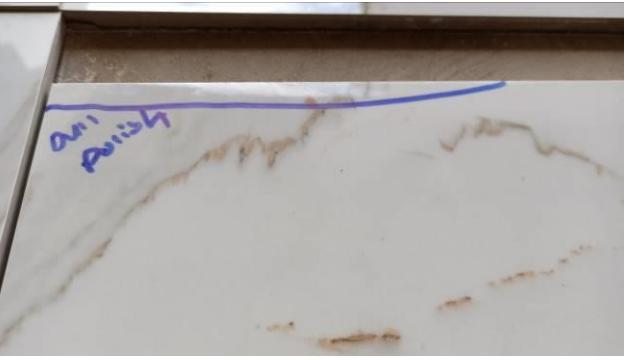
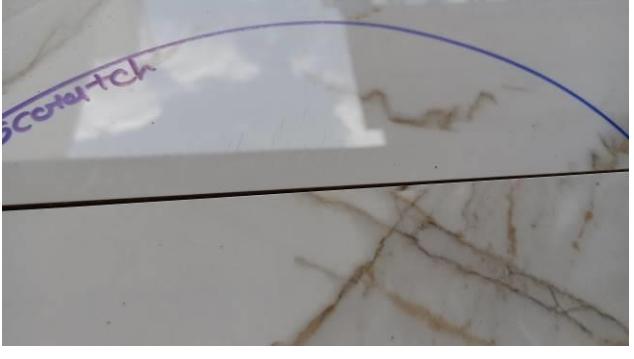
MINOR – PINHOLE

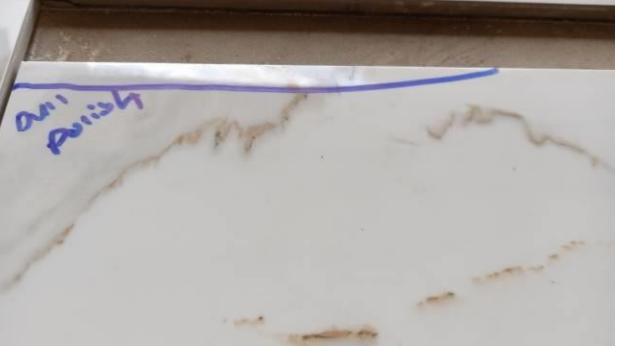
MINOR – CHIPPING	MINOR – PINHOLE

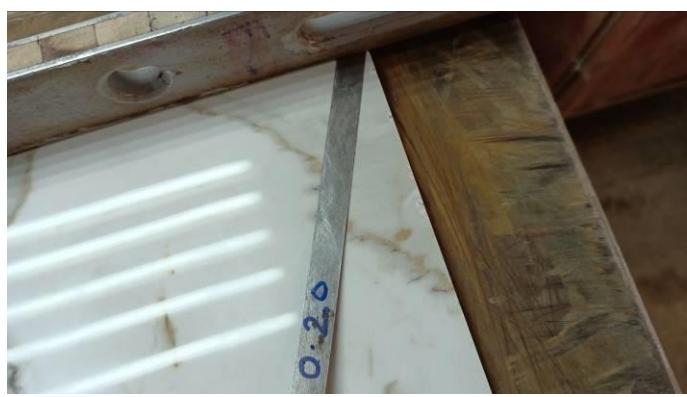
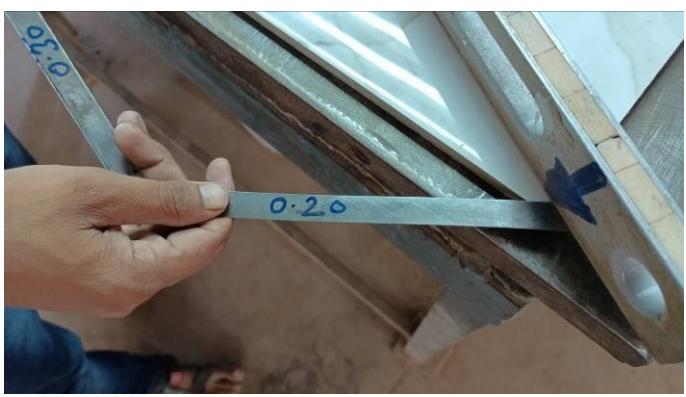
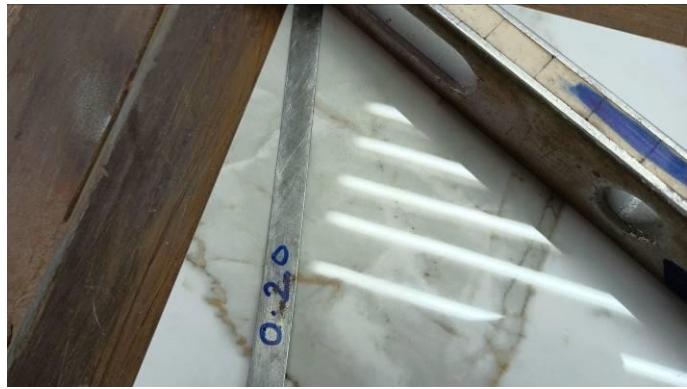
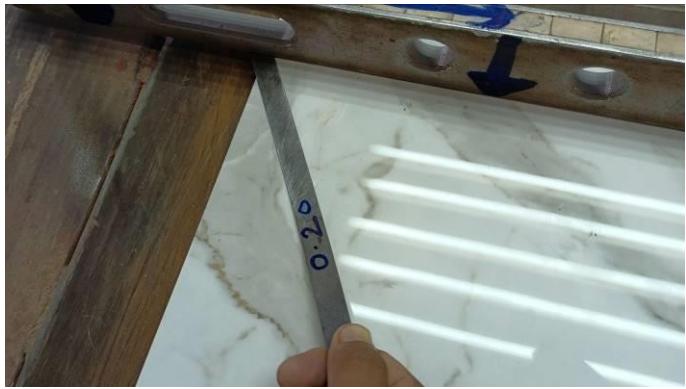
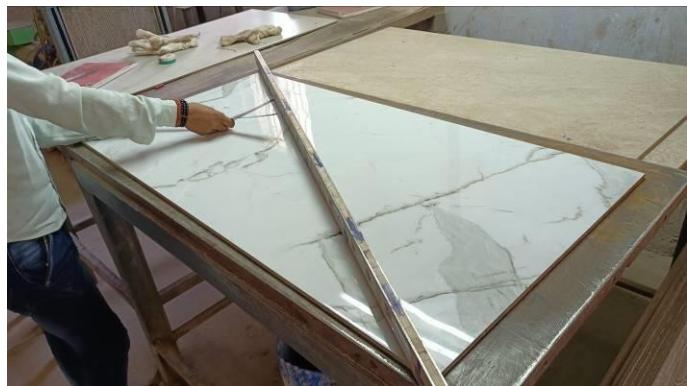
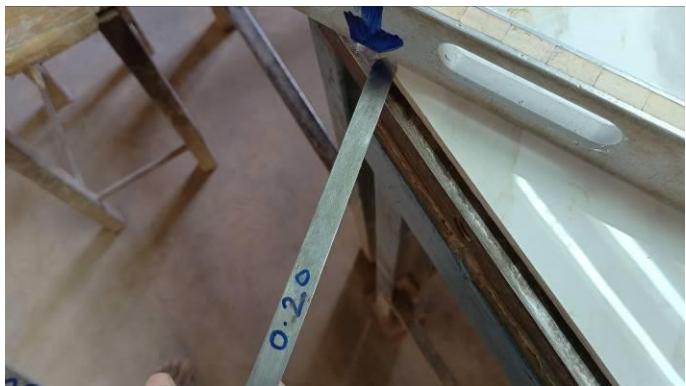
Description	Comments from	Result
<p><b>On-site Test:</b> Surface flatness</p> <p><b>Comments:</b> <math>\pm 0.1\%</math> is accepted, but different flatness in same piece like wave rejected.</p> <p><b>Sampling Level:</b> 5 pcs per item</p>		PASS

#### UNDER PARAMETER

SIDE = - 0.30MM

DIAGONAL = - 0.40MM

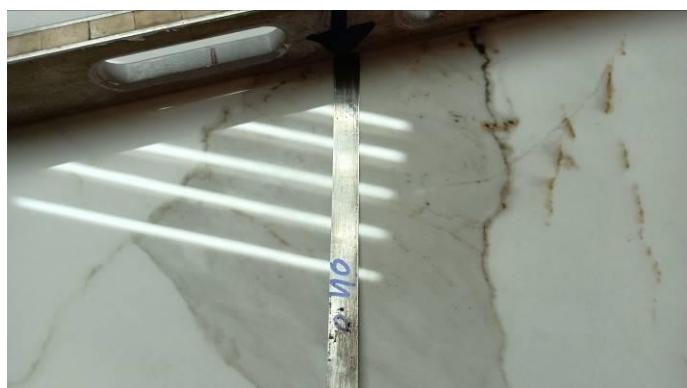
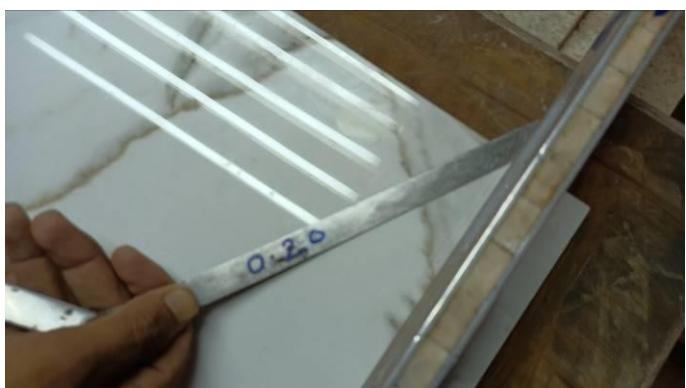
**On-site Test: SIZE & DIAGONAL TEST**  
**Comments: +/-0.1%**  
**Sampling Level: S-2 (04pcs)**

**ACTUAL READING AVG.**  
**SIZE VARIATION – 0.2MM**  
**DIAGONAL VARIATION – 0.5MM**

**PASS**

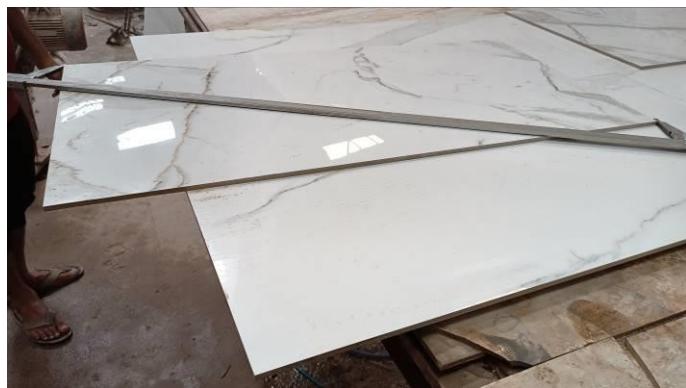
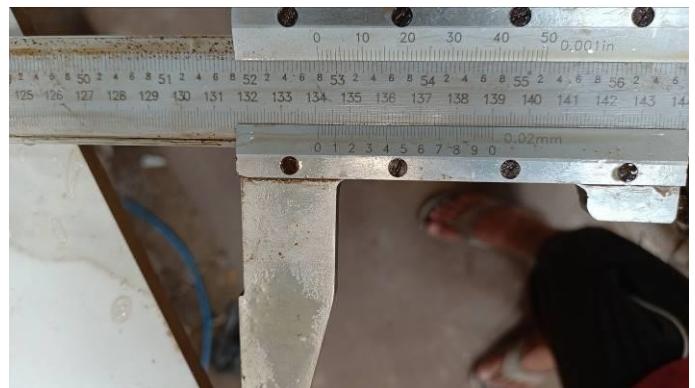
**On-site Test: Thickness measurement:**

**Comments:** Should be within +/- 0.50MM of specified thickness. Ensure the thickness of same piece is even, when we put tiles together, they are smooth on floor, no any wave.

**VARIATION UNDER 0.50MM**

**PASS**

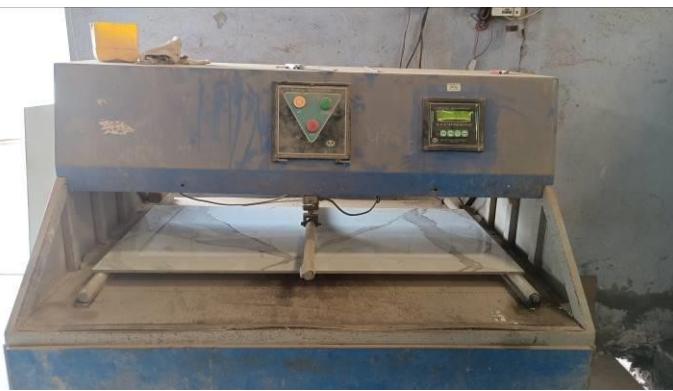
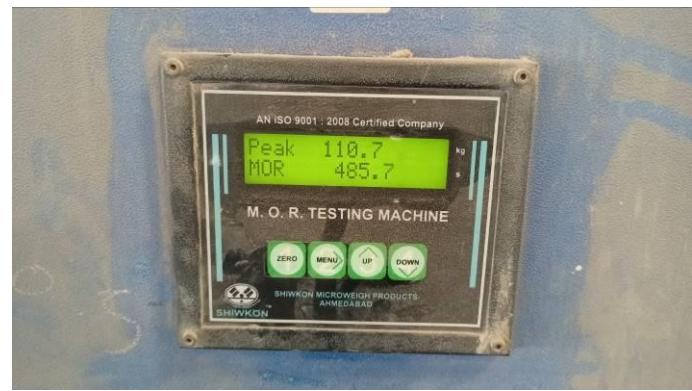
**On-site Test:** Breaking strength check

**Comments:** For thickness  $\geq 7.5$  mm: should be + than 380kg/cm<sup>2</sup>.

**M.O.R RESULT = ALL  
READING IN KG/CM2  
REQUIRED 380+ KG/CM2  
TILE- = 485.70KG/CM2**

**PASS**

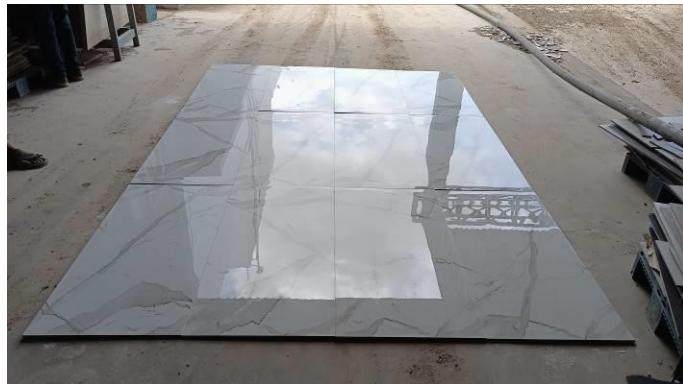
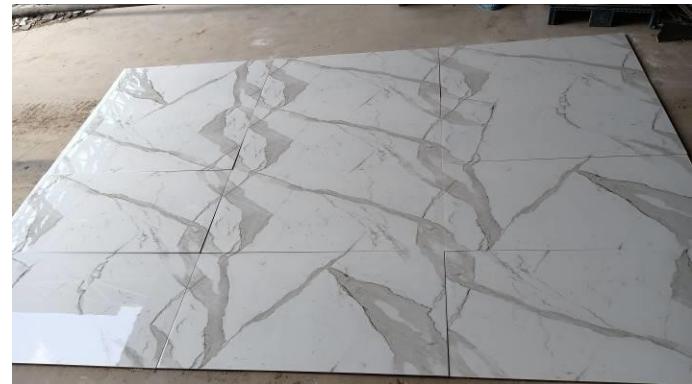
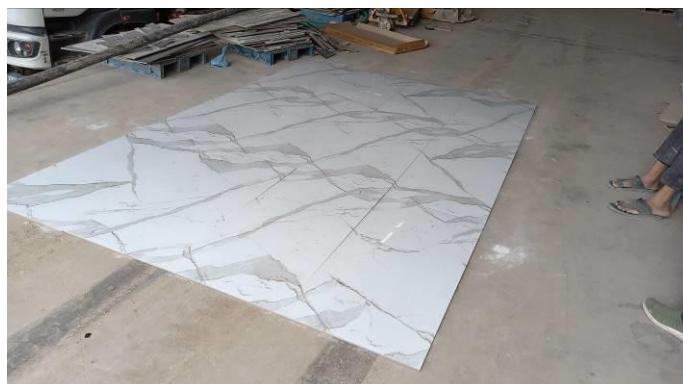
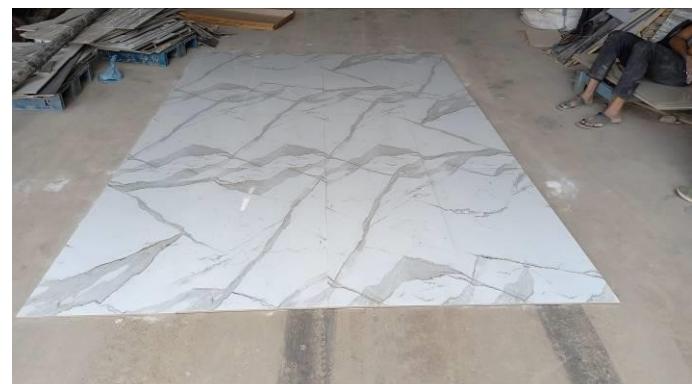
**DESIGN – REAL STATUARIO**

**On-site Test: Color Shading check:**

**Comments:** Lay down the tiles on the floor and check that all the tiles are of the same shade. NO shading between tiles is allowed and no shading within the tile is allowed.

NO SHADE VARITATION FOUND

PASS

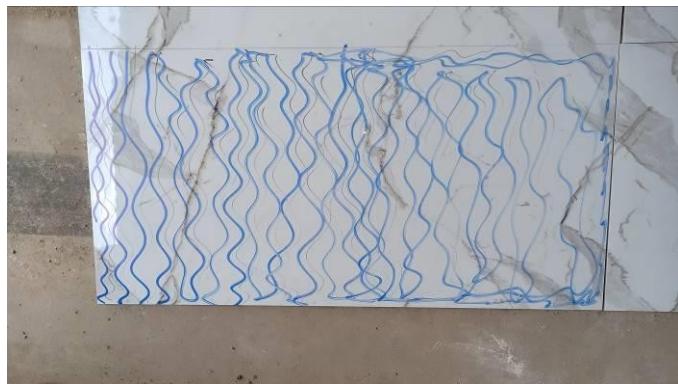
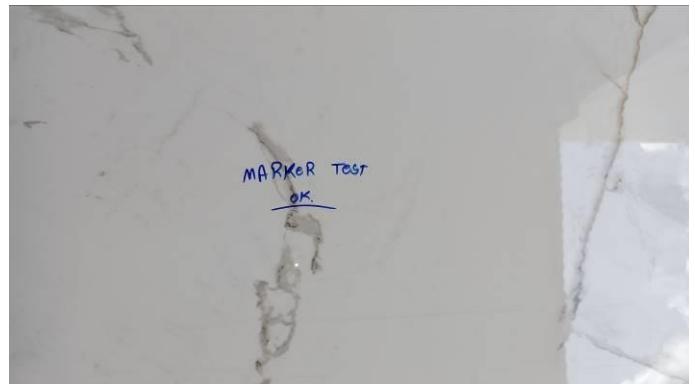
<b>On-site Test:</b> Packing list consistency check: <b>Comments:</b> <ul style="list-style-type: none"><li>- Total quantity</li><li>- Quantity per reference</li><li>- Number of pieces per cartons</li><li>- Number of cartons per pallets</li></ul> <b>Sampling Level:</b> S-1	<b>TOTAL 1830 BOXES READY PACEKD IN CARTOON</b> <b>2 PIECES PER CARTOON</b> <b>TOTAL 1 DESIGN.</b>	confirmed
<b>On-site Test:</b> Staining test <b>Comments:</b> After removing the Wax-> 1/ with marker 2/ This must be performed by Thinner or Ink water, choose one of five pieces to do it, painting the whole surface, all ink removed are accepted. If some pieces are found ink can't be removed, check more pieces to ensure it. <b>Sampling Level:</b> 2 PIECES		PASS

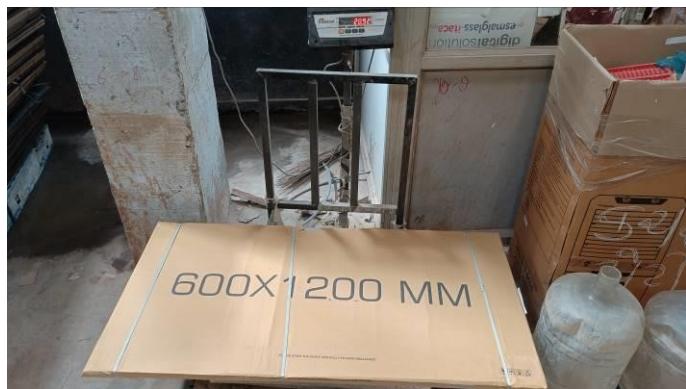
**BOX WEIGHT**

**On-site Test: Carton weight check**

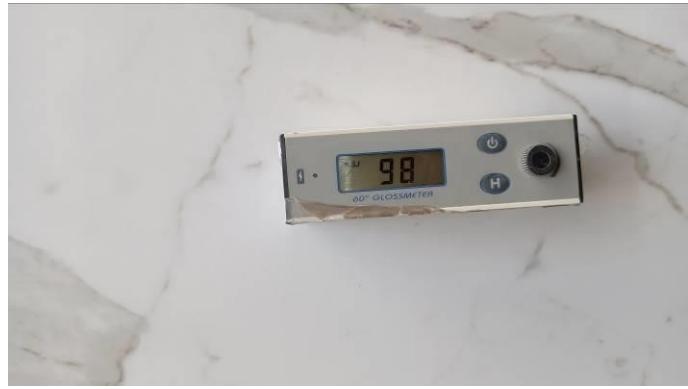
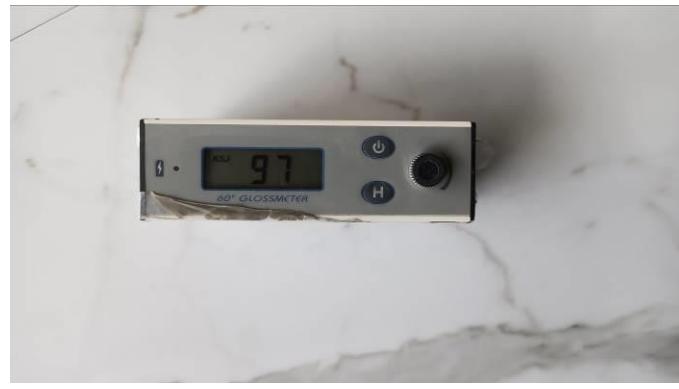
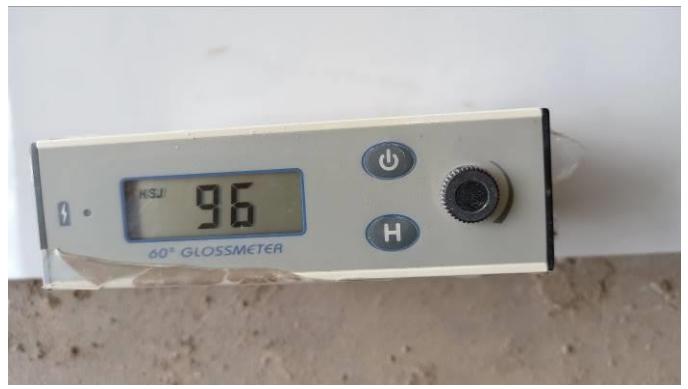
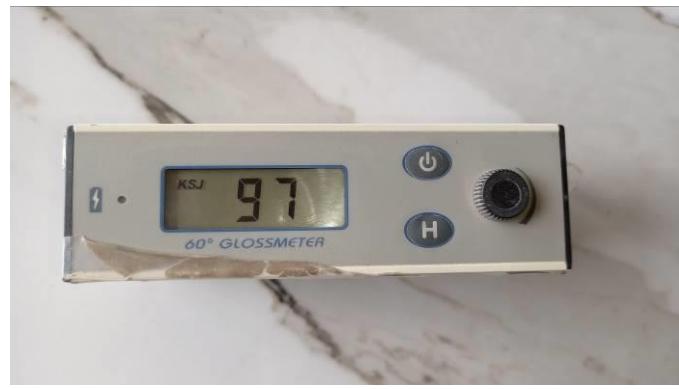
**On-site Test: Glossy check****Comments:** check 9 points on tile must be above 90>**Sampling Level:** 2 pieces**UPTO  
CLIENT**

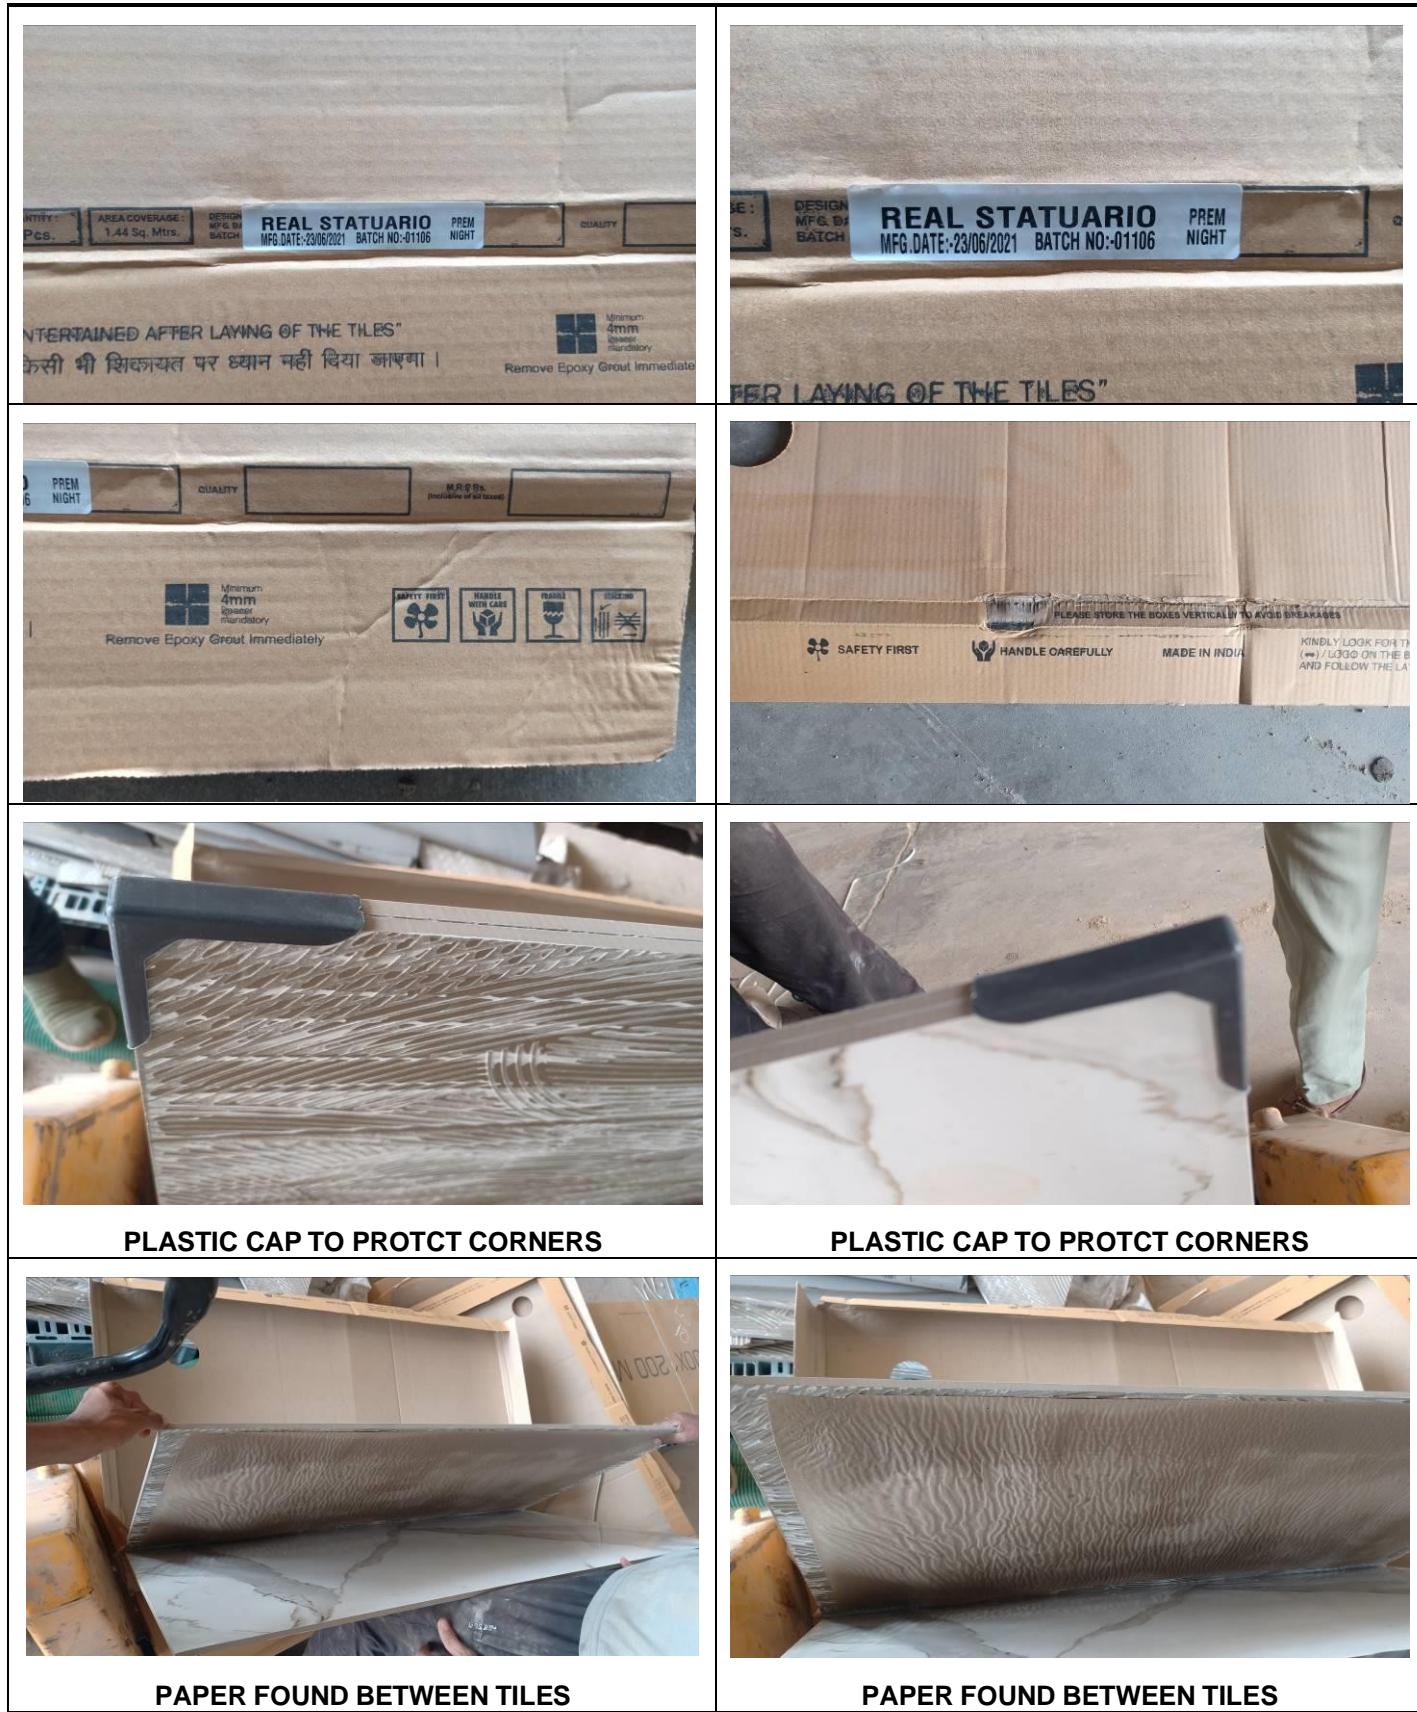
Photos: STICKERS & PACKING & BARCODE

Style/item/ Reference Number	PO number	Order Qty	Available Qty			Not finished QTY (pcs)	Sample size from	
			Packed (Pcs)	Packed (CTN)	Unpacked (Pcs)		Packed Lot	Unpacked Lot
PGVT 60X120CM	1	1830 Boxes	3660	1830 Boxes				
<b>Comment:</b>	<b>2 containers</b>							
<b>Note:</b>	MATERIAL PACKED IN CARTOON YET NOT PALLISED.

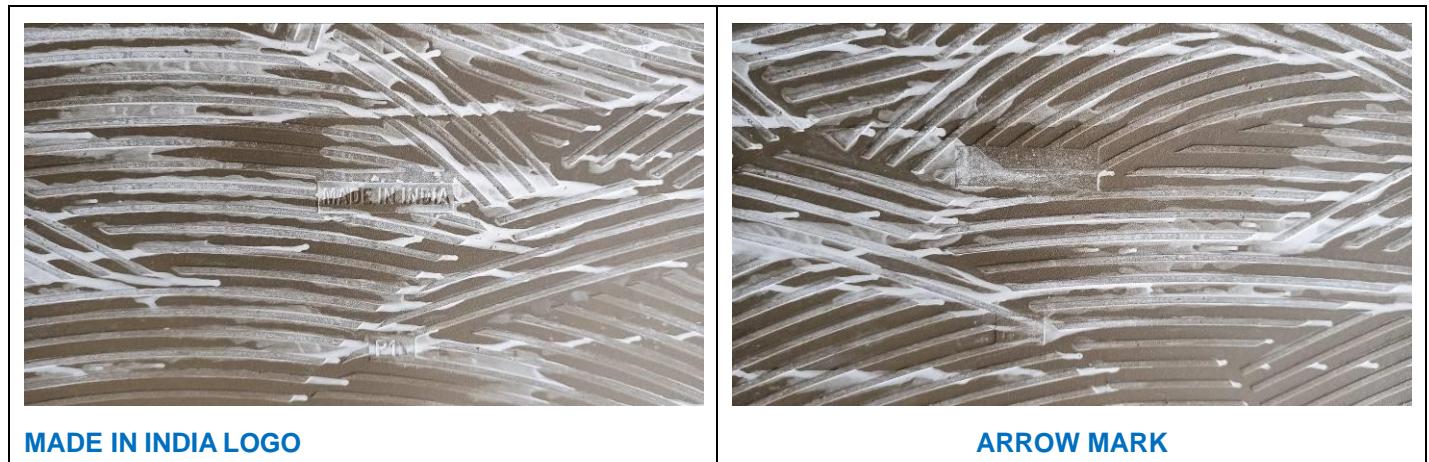
INDIAN ISO STANDARD:	Result	Comment
	OK/ NOT OK / N/A	
<b>Compared with approval sample</b>	N/A	
<b>- Style:</b>	N/A	PGVT – 600X1200MM
<b>- Color:</b>	N/A	
<b>- Logo:</b>	OK	MADE IN INDIA LOGO FOUND
<b>-Marking/Label:</b>	OK	STICKER FOUND IN EVERY BOXES
<b>-Country Origin label:</b>	OK	
<b>- Others</b>	N/A
